APPENDIX A DUNURE HARBOUR

Dunure Harbour, Dunure: Archaeological Assessment

issued 27th June 2022

RATHMELL  
ARCHAEOLOGY LTD

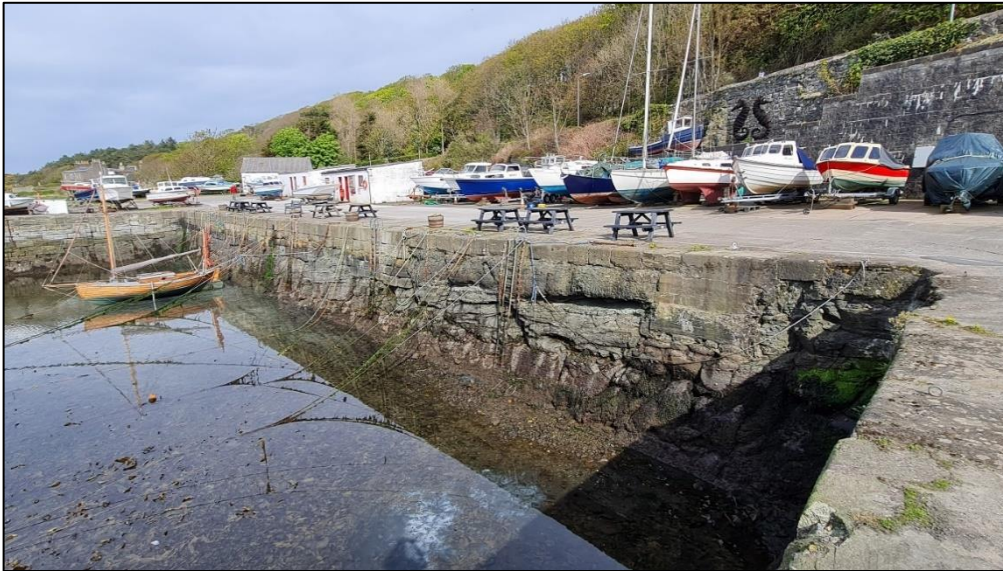
Figure 6a: Outcrop & Revetment Walling in E Wall **B2** of Harbour

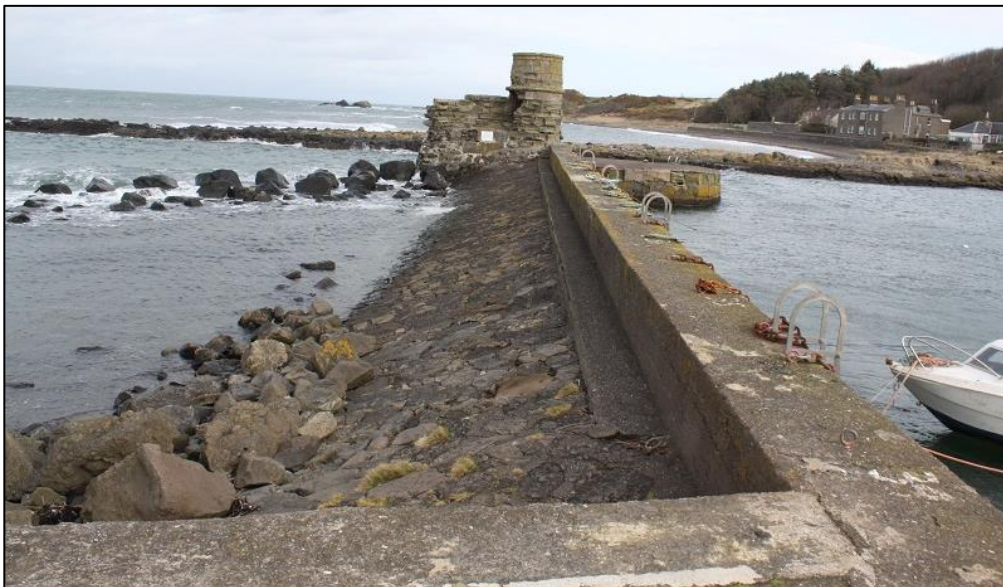
Figure 7c: View Along West Wall **B4**, Showing Line of Raised Walkway

106. The construction of the new wall-head access path (e) will overlie the concrete cap of the West Wall **B4** and the screed to the rear. This is not anticipated to result in substantive loss or damage of archaeologically significant structures that embody complex archaeological information. The archaeological impact of this work is considered to be insignificant.

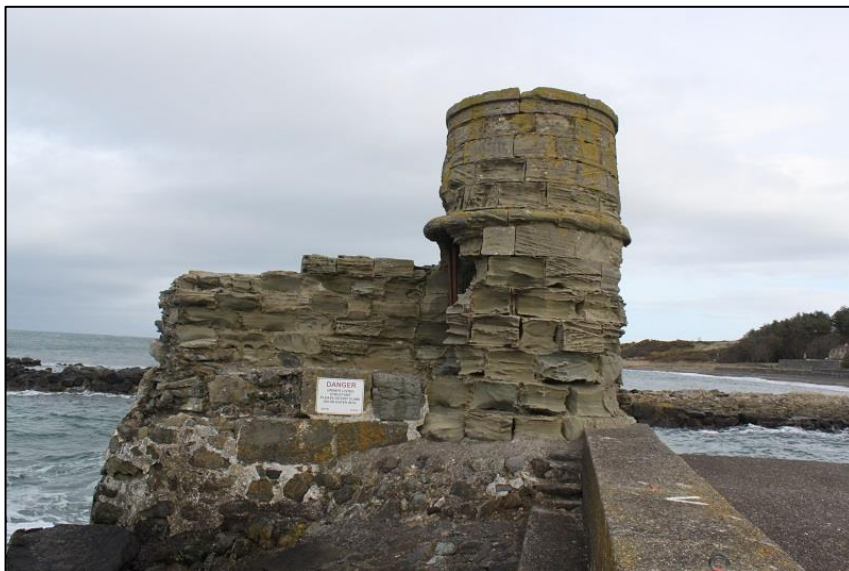
93. Arguably the most distinctive feature of the west pier, and indeed of the harbour basin as a whole is the lighthouse **C**, which sits at the north end of the west pier **B4** (Figure 8b). An integral part of this feature is the occulting wall which extends westwards from the base of the tower: this acted to mask or reveal the opening at the base of the tower, and the fire burning within, thus enabling ships approaching from either north or south to steer safely into the harbour.

94. The fabric which makes up the lighthouse comprises a similar pale sandstone to that used in the upper courses of the harbour walls, though here, over the lower half of the structure it shows signs of heavy erosion, more so on the west and south sides to the south of the occulting wall. Another important feature to note is the presence of a prominent rolled string course located approximately two-thirds of the way up the height of the tower. This string course is of similar character to another rolled moulding on the external wall face of the east side of the north wall of the basin (Figure 8c), where it has been laid along the line of the walkway, forming the plinth course for a low parapet wall which runs along the northernmost, external, edge of the north pier **B1**. The consistent appearance of this rolled moulding throughout the pier walls further supports the argument that the pier walls, in their surviving form, largely represent a single episode of design and construction.

Figure 8b: Lighthouse **C**, Showing Rolled Moulding and Occulting Wall

109. The restoration of lighthouse **C** including the occulting wall (b) is anticipated to encompass the full dismantling and rebuilding of this structure with substantial stone replacement. Inspection of this structure has shown that it is unlikely to embody complex

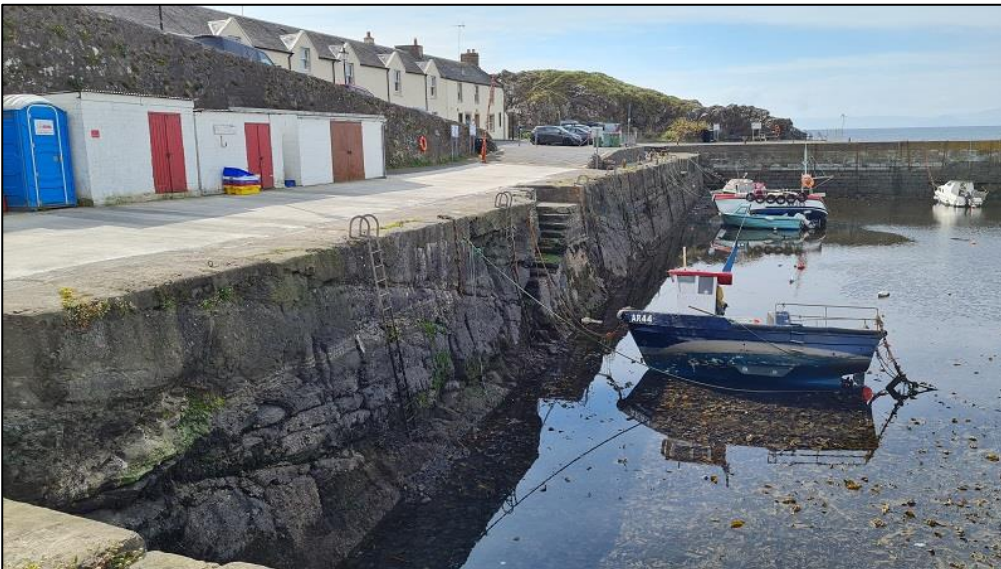
Figure 9b: Current Access Arrangements at South Wall **B3**

95. One area where significant change is evident, however, is in the ground levels and access arrangements of the south wall **B3**. Historic images of the harbour (e.g. Figure 9a) show that land access to the harbour facilities was via a narrow road which climbed steeply up from the quayside along a line roughly parallel with the adjacent street, angling sharply to the south at the junction between the two roads. In the original configuration, a parapet wall had been built along the edge of the landform, extending along much of the N side of the street and pierced only by the junction with the harbour access road and at the west end, where the south wall **B3** appears to be lower, allowing small boats to be pulled up onto a stretch of shallow sloping ground in the SW corner of the basin.

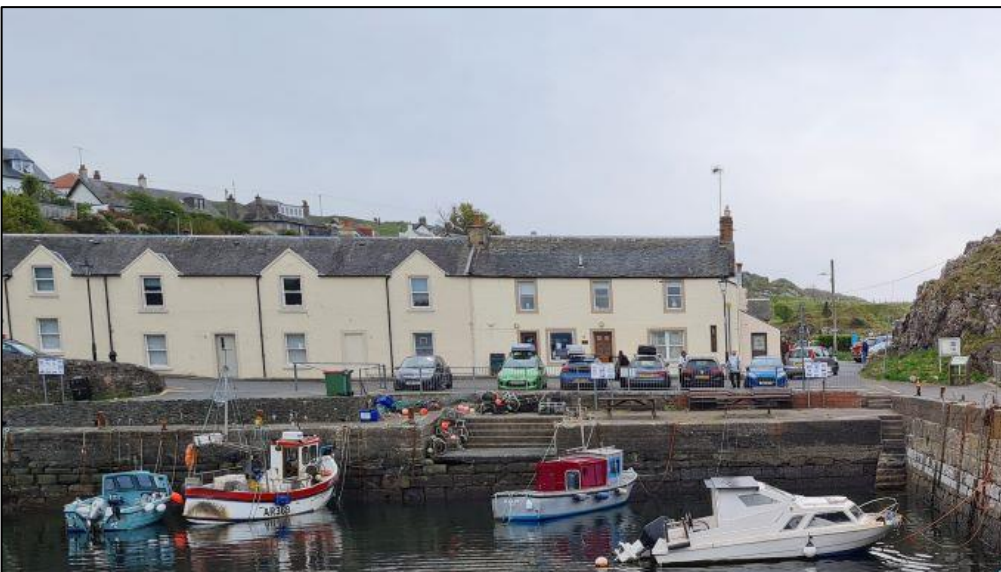
Figure 9c: Lowered section of South Wall **B3**

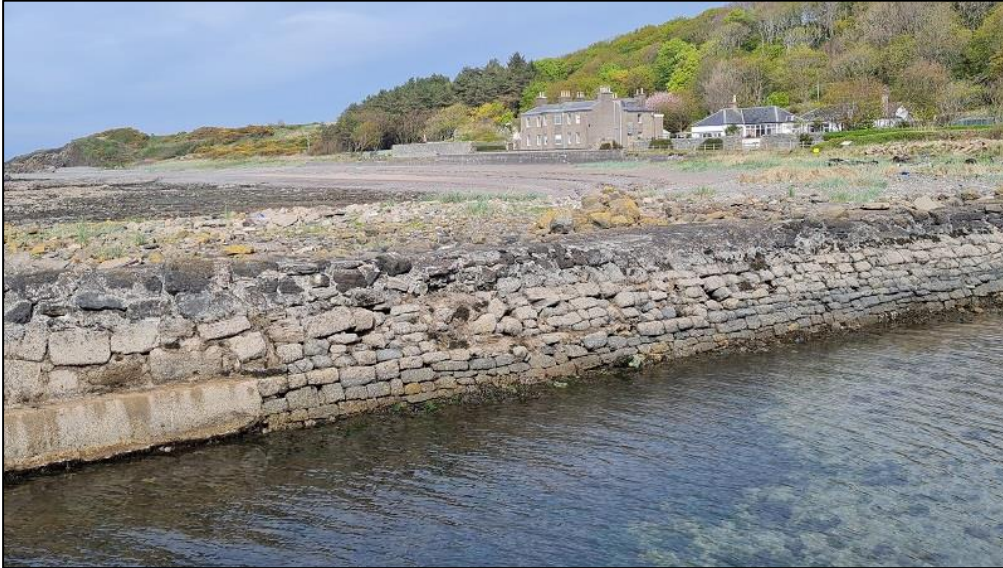
Figure 11a: Detail of Central Portion, North Breakwater **D**, Showing Variation in Masonry

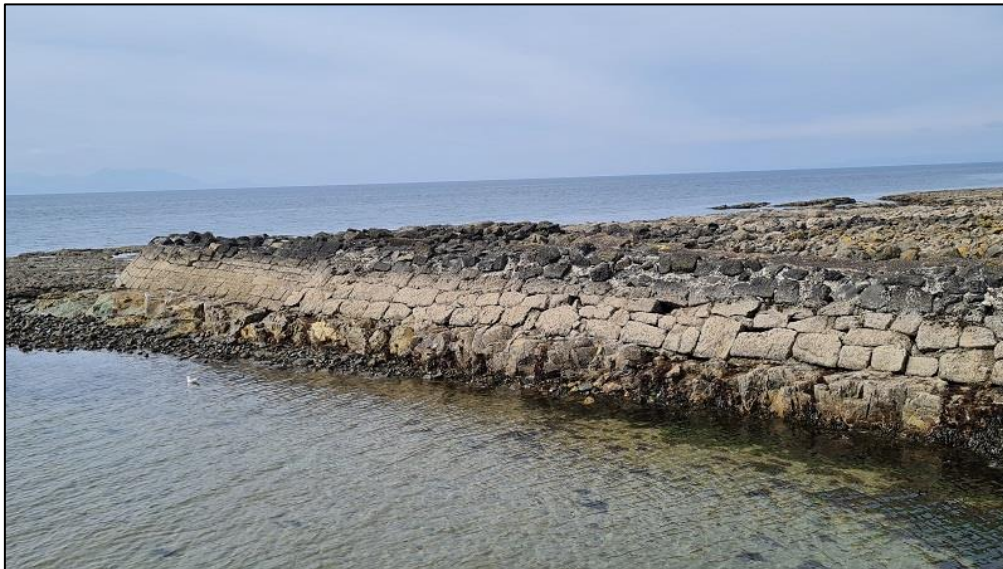
Figure 11b: Detail of W End, North Breakwater **D**, Showing Variation in Masonry

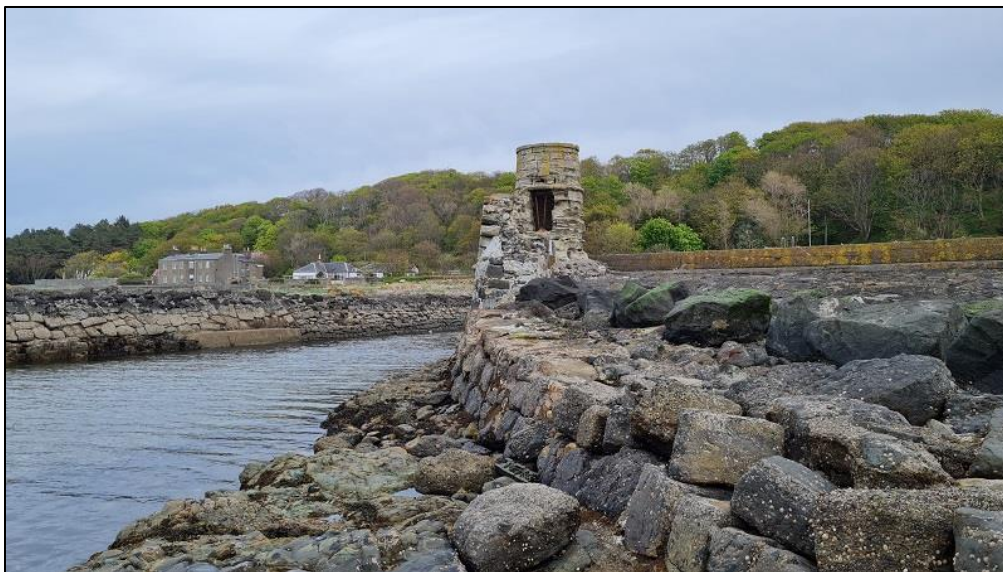
Figure 11c: W Breakwater **E**, Masonry Exposed at Low Tide
