2.5 FOUNDATIONS for RECOVERY

DUNURE HARBOUR CONSERVATION STRATEGY

DUNURE HARBOUR SOUTH AYRSHIRE KA7 4LR

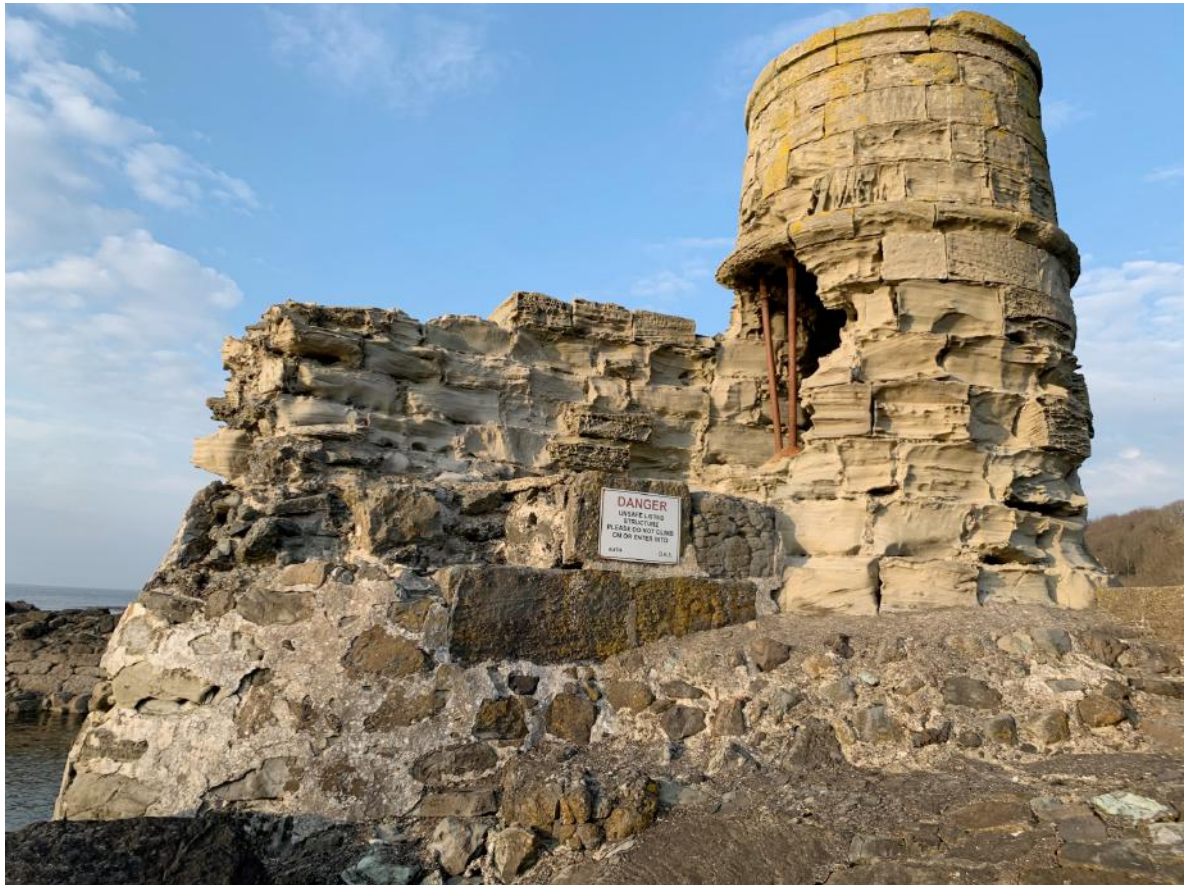
Condition of the Lighthouse structure and occulting wall has deteriorated badly with major erosion and temporary supports are also corroding

Lighthouse: The Lighthouse is in very poor condition with almost all stones severely eroded to the point of unpredictable structural capability. The stonework will require major repairs and given the nature of the decay, full stone replacement with a more durable unit will probably be required throughout the structure.

Restoration of the Lighthouse: recommend dismantle and rebuild with new stone to lower 2/3rds of structure (below the roll course) and rebuild upper section with re-use of existing stone and localised replacement indents cut from salvaged stone.

As a minimum, if the stonework is not to be restored for some time, the replacement of the corroding steel props with stainless steel props, should be carried out with some urgency.

Consolidation of the occulting wall: recommend take down upper and west outer edge stonework and rebuild with new bedding and pointing to consolidate the structure.

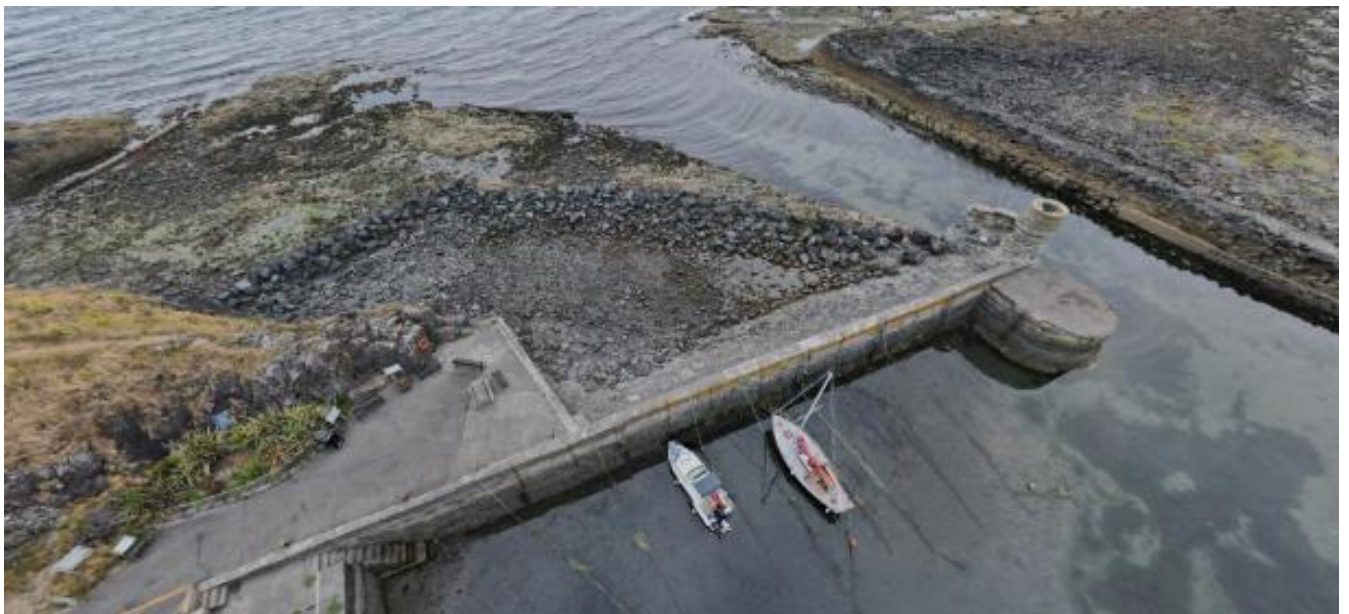
Harbour walls: The wall facing the harbour is generally in reasonable condition given the past maintenance regime but is in need of remedial works to sections of the wall. Erosion and displacement of some stones will need to be remedied with deep packing, pinning and repointing of the masonry with lime mortar or grout.

West Breakwater and Quay: The west revetment is covered with concrete which was cracking to the northern end. This will need to be repaired using standard concrete repair grouts.

Aerial view of West breakwater, quay, harbour wall and Lighthouse

West sloping Quay: grouting of holes and crevices on the sloping concrete and stone surface, with a strong cement mortar to prevent wave action erosion. This should be carried out, regardless of the suggested concrete walkway and barrier structure being built. The steps from the fenced general viewing area to be repaired to give safe access along the west harbour wall.

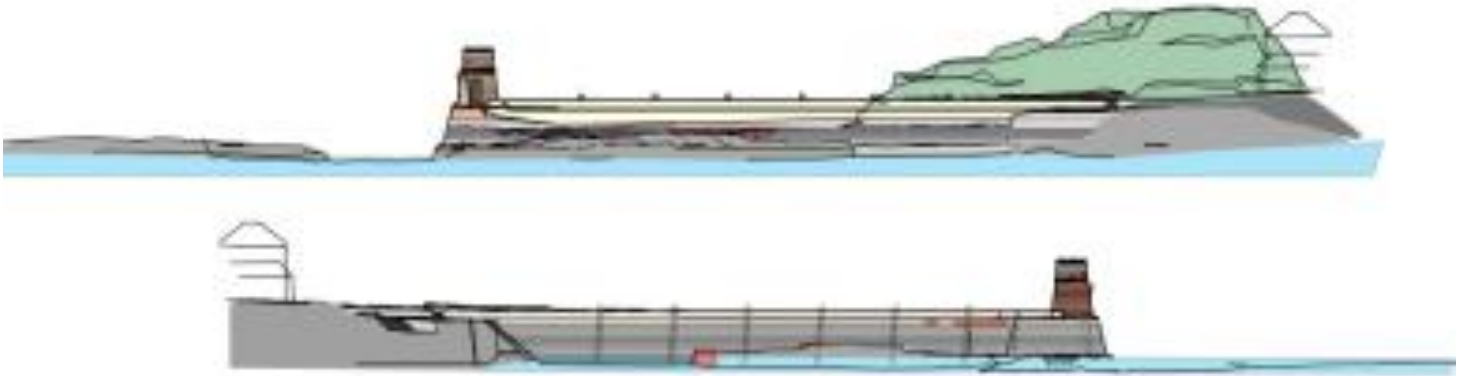
Sectional elevation drawings of the Lighthouse, West wall and Quay.
Reference to the technical survey and proposed repair drawings for detail.

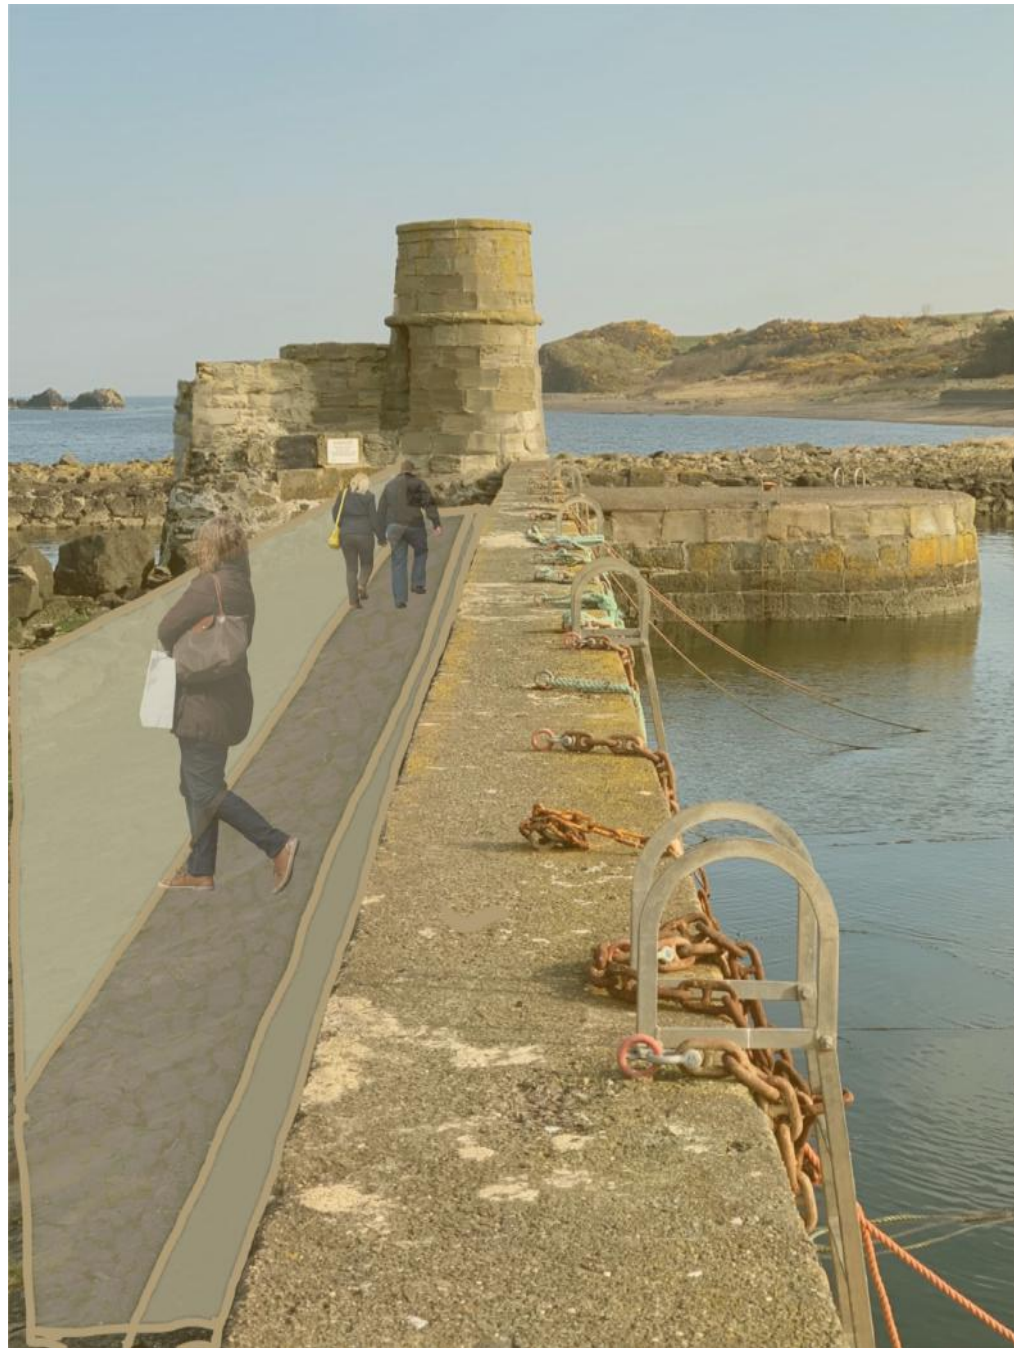
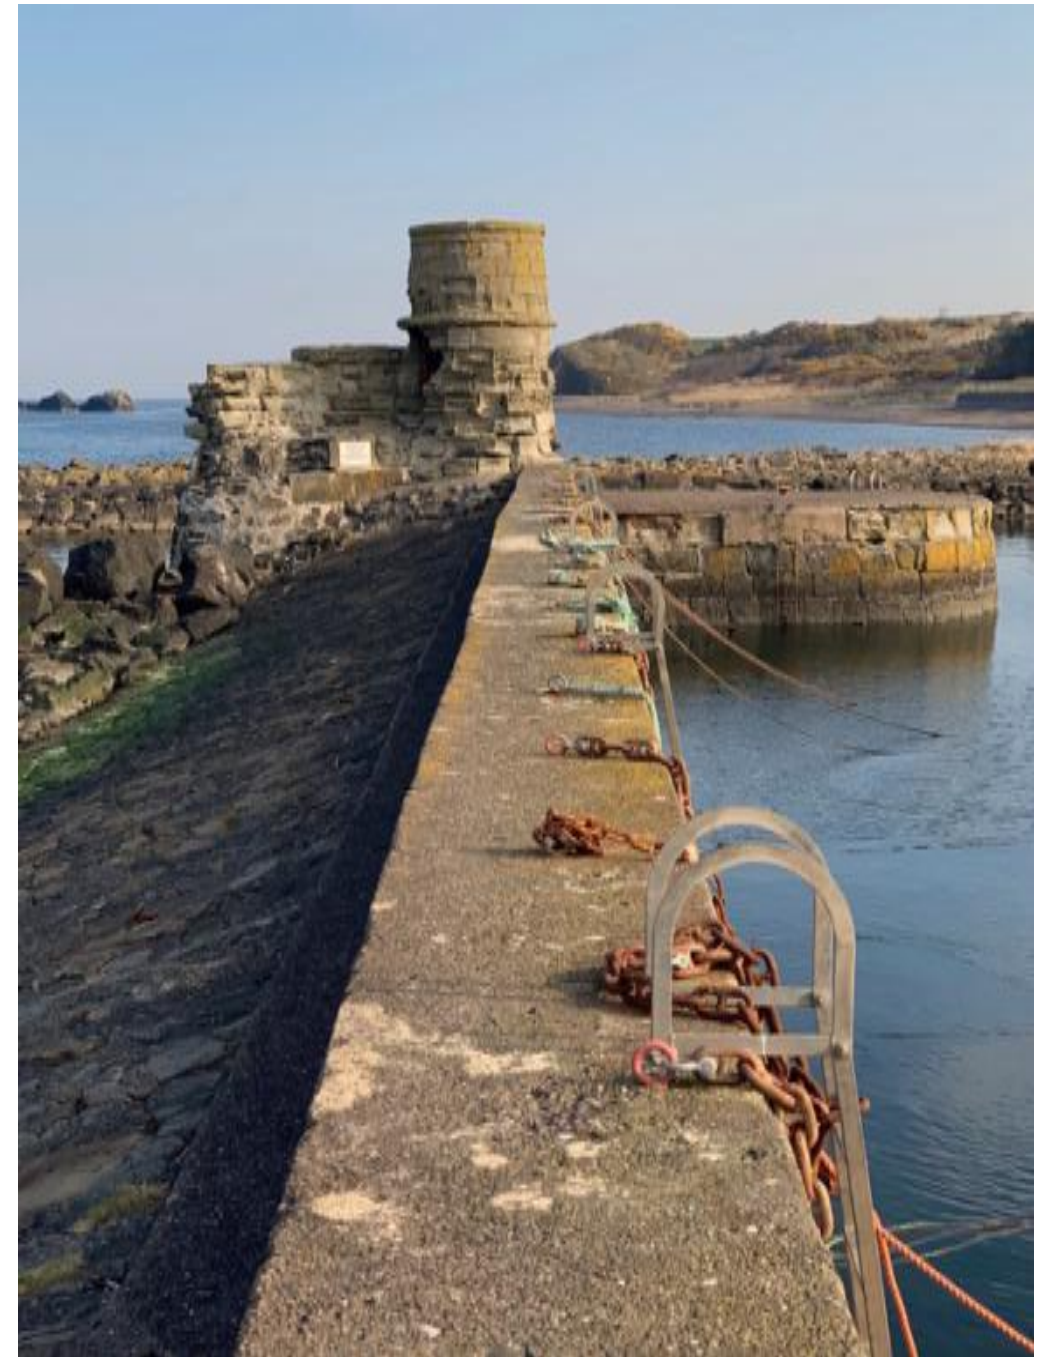
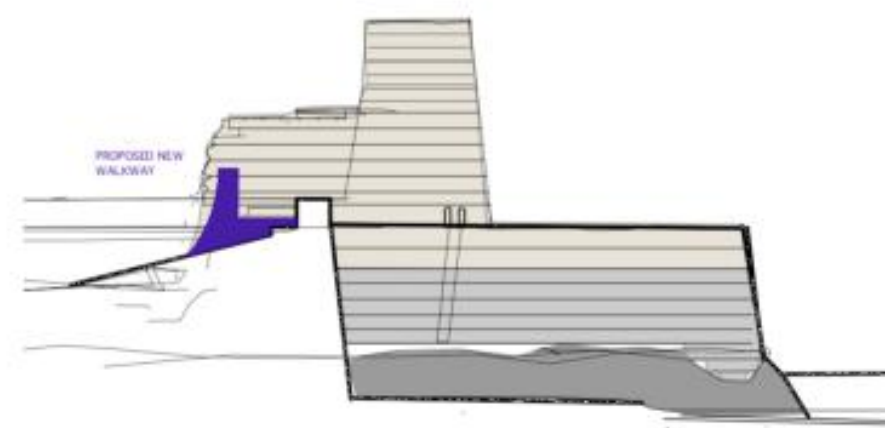
JOB			DUNURE HARBOUR
DRAWING			BREAKWATER IMAGES
SCALE	DRAWN	DATE	
NTS	GF	JUL 22	
DRAWING NO			REV
6464 - DH - 11			
CLIENT			
NCCBC

The existing breakwater is overwhelmed by hightides. This proposal looks to increase the height of teh breakwater and to use this new structure to create a walkway allowing visitors to walk out and inspect the lighthouse structure more closely.
