6.0 FOUNDATIONS for RECOVERY

STRAITON

6.4 McCandlish Hall

6.5 STRAITON MONUMENT CONDITION REVIEW

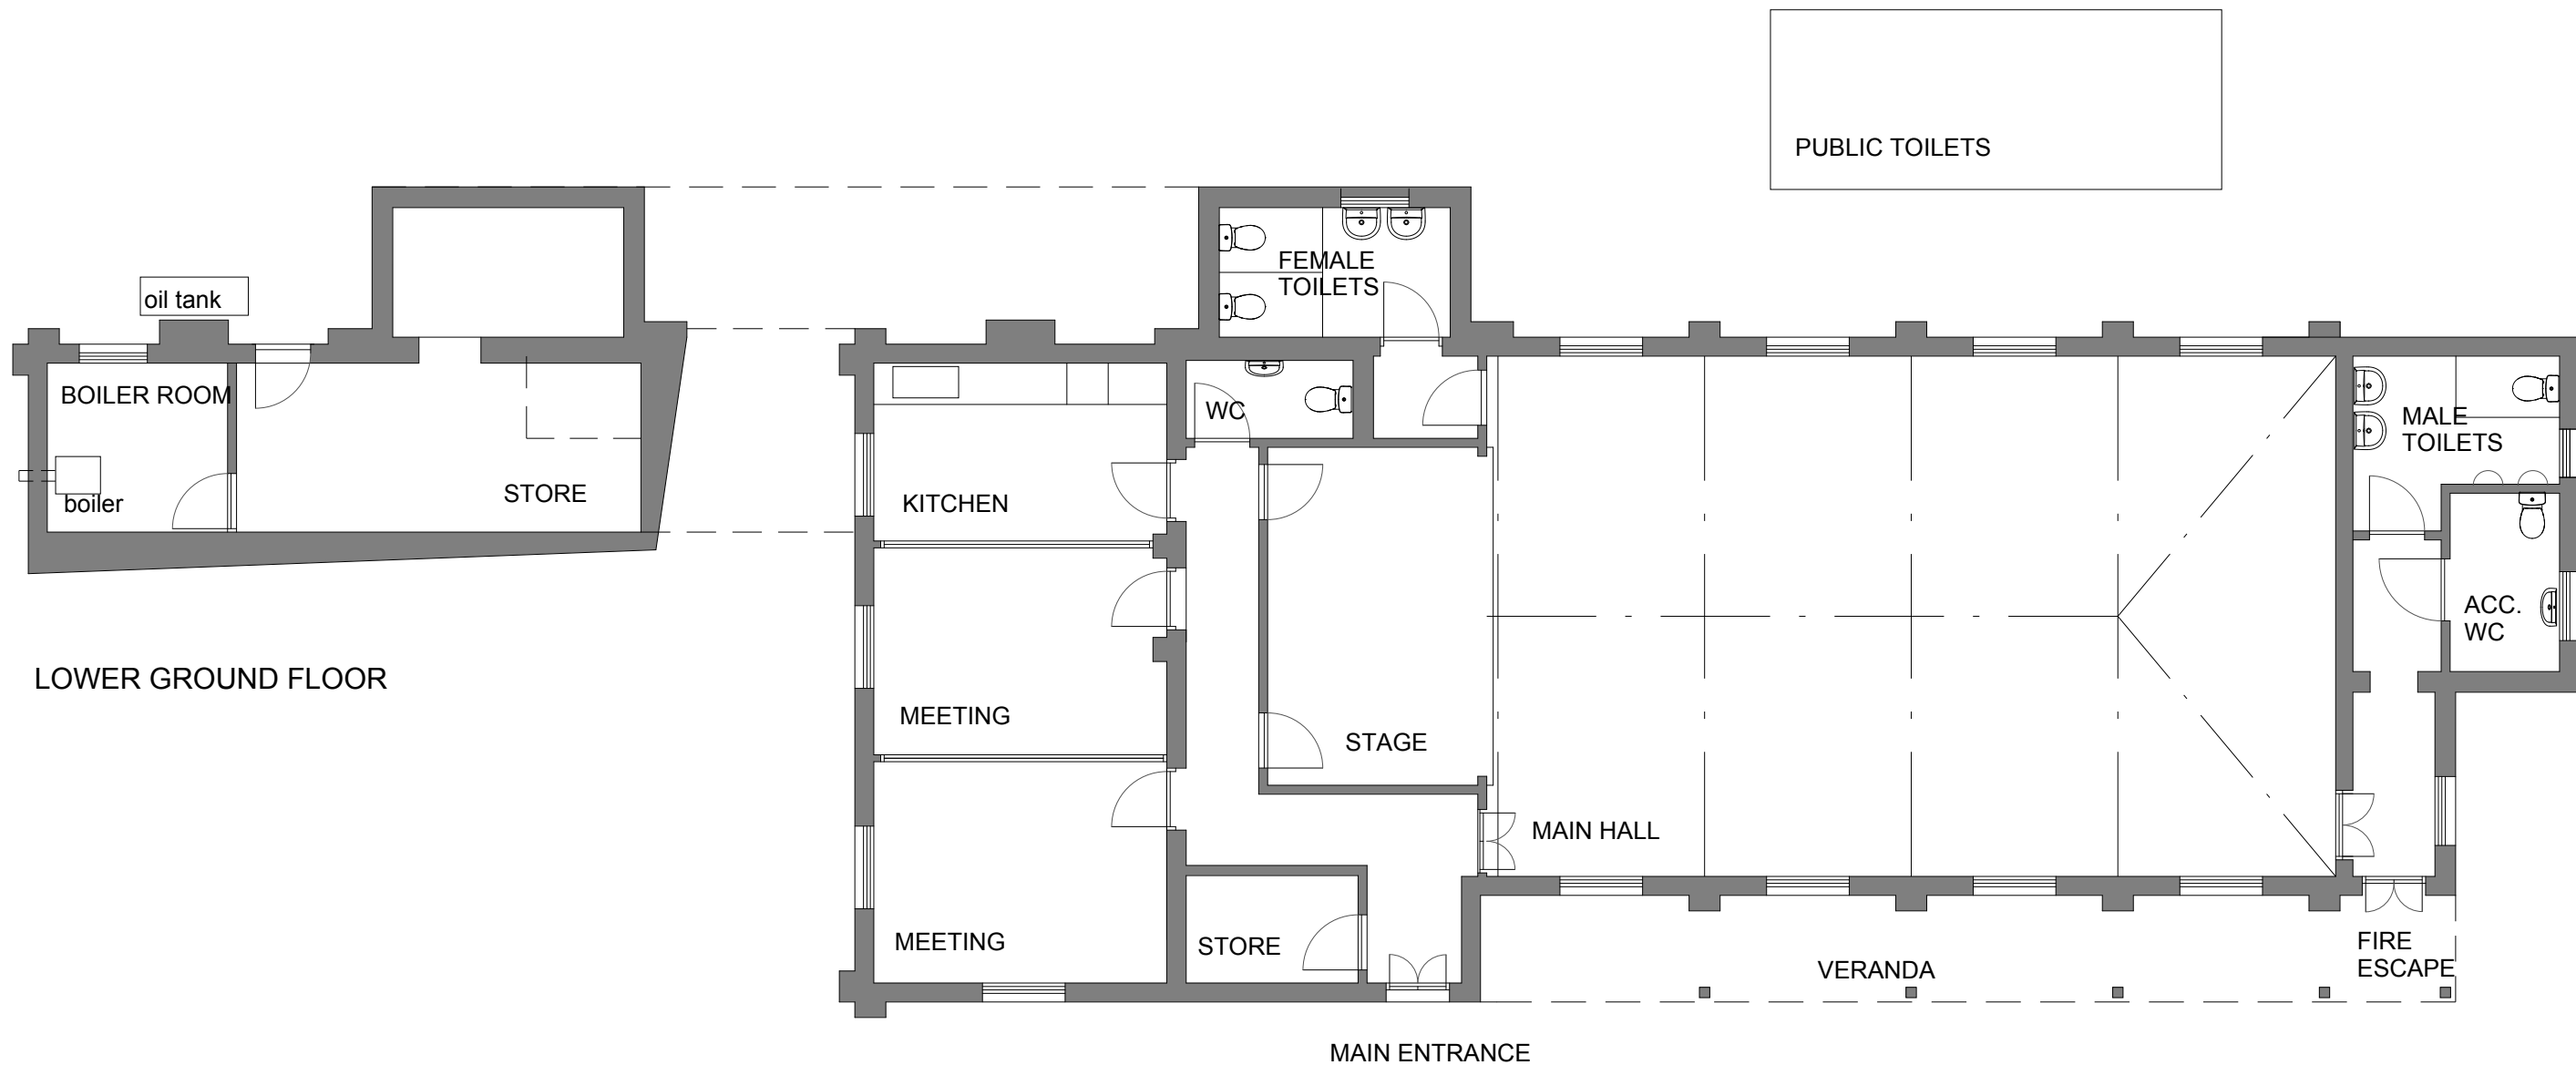
JOB	McCandlish Hall Straiton		
DRAWING	Floor Plan		
	As Proposed-		
SCALE	1:100	DRAWN	DATE
	@A3	GF	Aug 22
DRAWING NO	6464.S.GA.01		REV
CLIENT	NCCBC		
ARPL ARCHITECTS 11 WELLINGTON SQUARE, AYR TEL 01292 289777

- 2 Insulation and draught stripping of ground floor
The space under the stage suffers from excessive air movement. During the survey wind was whistling through this space suggesting it is open to the outside in some form. Closing up any gaps, lining the floor and insulating wherever possible should make a significant difference to the heat loss under the floors. This would include the lower ground floor storage area.

- 4 Insulate boiler room
The boiler generates heat in operation. At present this heat is lost to the outside. As with the underfloor insulation a limited amount of insulation could be used to upgrade the boiler room enclosure to ensure the heat is retained within the building envelope rather than lost

- 1 Upgrade of windows.
Replacing the windows with new double glazed draught stripped windows will be a major improvement. This is already in planning and partly funded.

- 3 Supplement roof insulation
The roof over the smaller meeting rooms is partly insulated. The missing areas should be infilled and where possible a second layer of insulation introduced over the attic floor joists.

10 The access to the building is currently via the main front door. There is a secondary door to the right-hand end of the main street elevation which is principally a fire escape. Both these doors have steps up from the pavement into the building. At present access is provided via a portable ramp to overcome the single step at the main front door. A more permanent solution would be desirable.

11 The other area of concern with regard to accessibility is the lack of unassisted access to the meeting rooms and kitchen. In order to overcome this issue a small platform lift could be installed in the storage cupboard to the left hand side of the internal stair this

- 12 The first option would involve building a small extension of the rear toilet corridor of the hall. In this location a storage room could be built to a size which was considered suitable to cater for all the storage needs. This is however an expensive option.
- 13 The second option would be to create a wall of storage across the rear end of the main hall this could be done with minimal reduction in the usable area of the hall but it would be limited to approximately six or 700 mm depth cupboards given the existing window positions adjacent to this. With careful consideration of what is stored where this would however give the facility for a reasonably large volume of storage space at a relatively lower cost. This could be done with timber finishes in order to preserve the existing character of the whole.

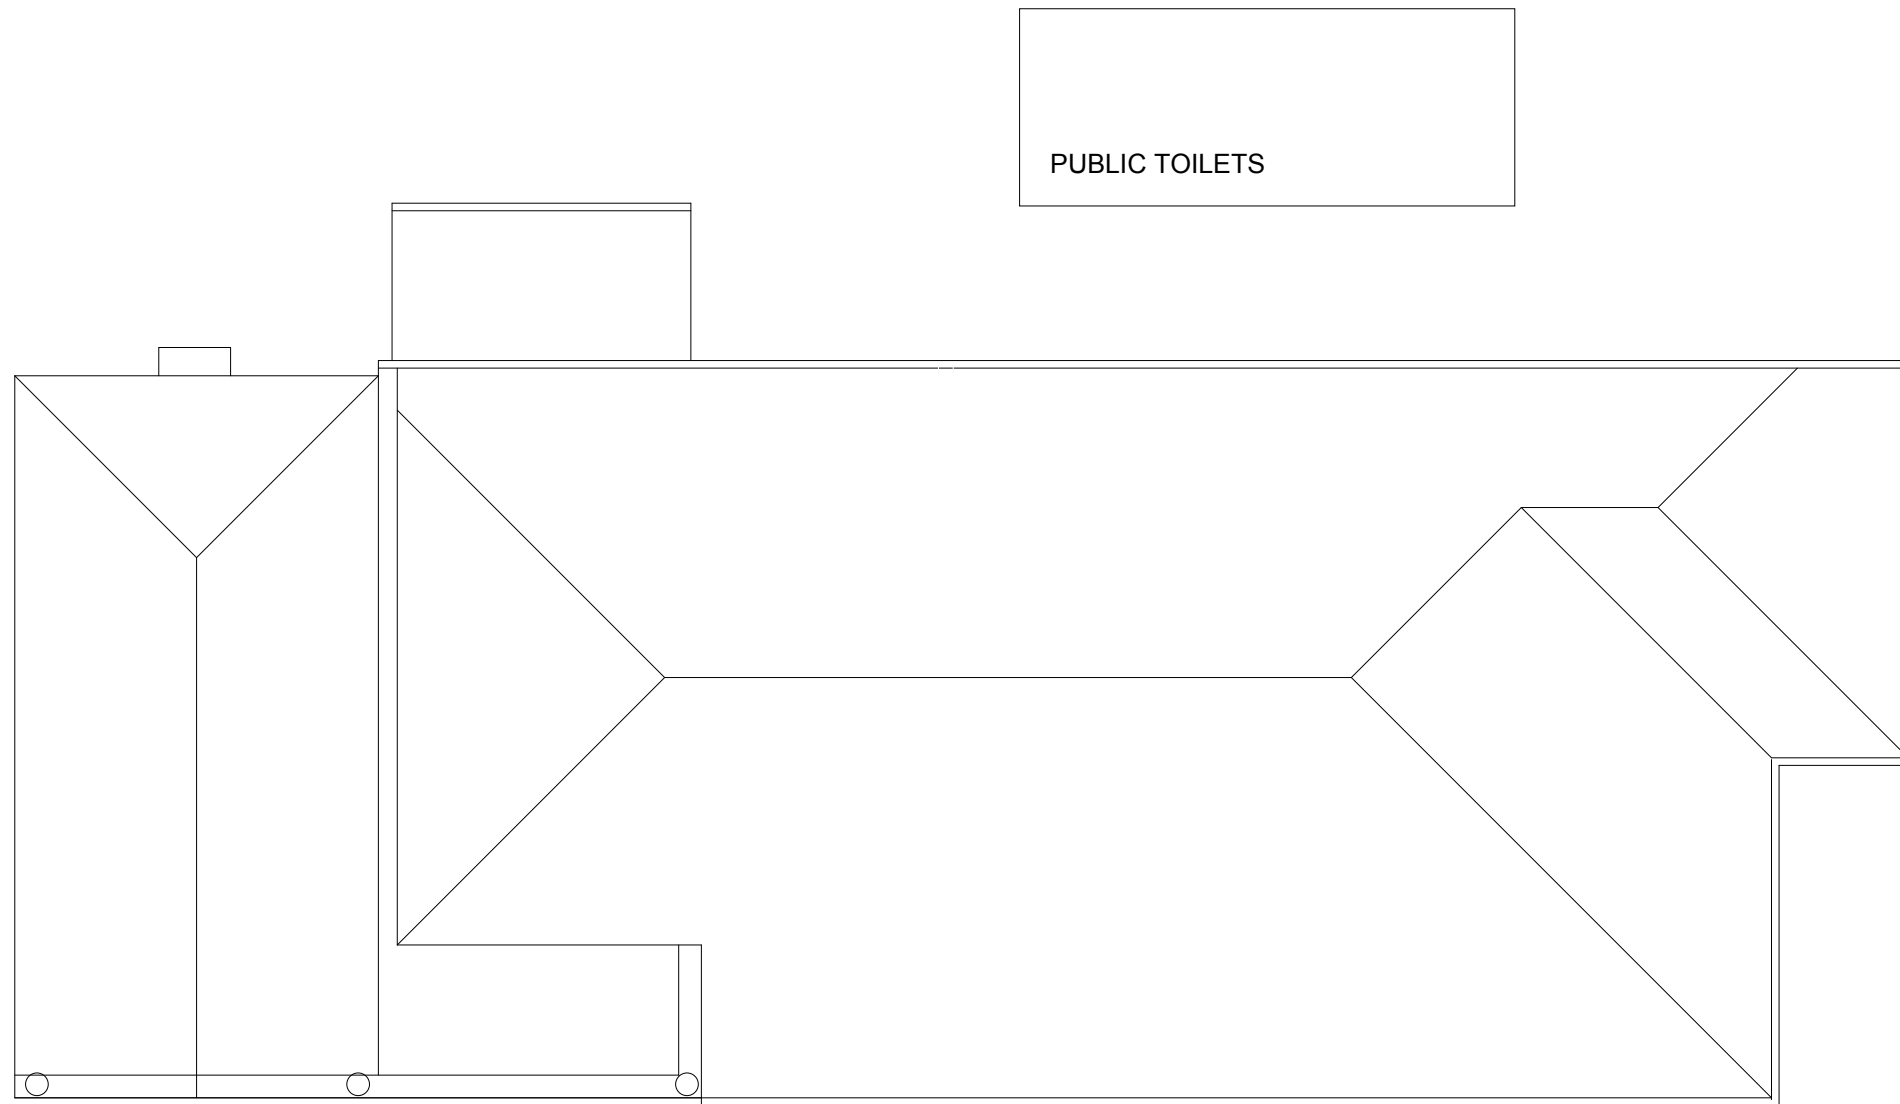
DRAWING NO 6464.S.GA.02 REV

- 7 Insulate main roof
The main area of heat loss in the building is undoubtedly through the main roof. This is a slate roof on sarking boards with the underside of the timber boards exposed to the main hall. To apply insulation to this roof is problematic. The simplest way to apply insulation would be to line the interior with insulation board and a new finish. This would however potentially change the character of the main hall significantly. The option which would avoid affecting the interior would be to apply insulation on top of the sarking this however would only sensibly be carried out if the main roof was being re-slatted.

Alongside the installation of a heat pump there is an option of fixing photovoltaic panels to the rear slope of the hall roof. The slope generally faces south and has little shadowing. This would make it ideal for the location of solar panels, generating power for the building. The main issue with this concerns the limited daytime use of the building. There are however options which would allow the benefits to be used at night or in darker winter days. If an air source heat pump is present the solar panels can heat the water in a buffer tank which would act as an energy store heated up during the day to be used with the heat used at night.

8 replace oil boiler with air source heat pump

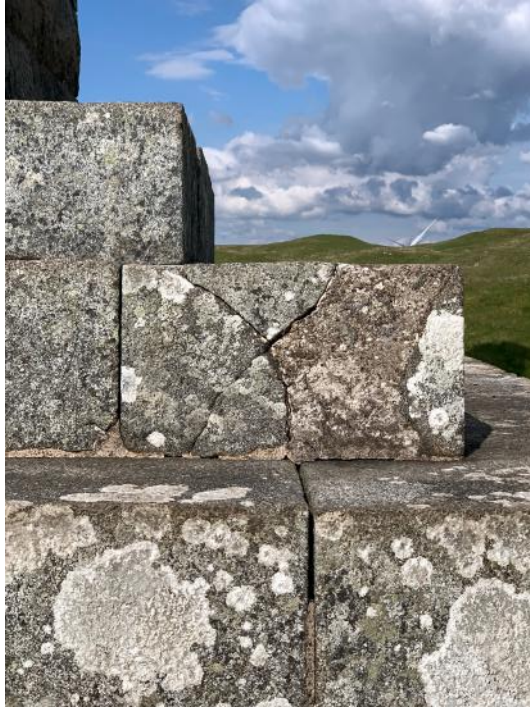
There are a few blocks on the stepped plinth which have cracks, which can be attributed to the general load transference to ground level, but these are not significant and there is no evidence of settlement or subsidence of the ground bearing. Cracks should be repaired with stainless steel pins and resin prior to repointing. A fair number of the joints on the step upper surfaces and vertical faces have lost mortar through weather erosion, the joints are generally 12 to 15mm wide, with a few wider, and will require deep packing full repointing with an appropriate lime mortar.

Stepped plinth with cracked stones
And open joints

1.3		Rake out to remove all cement mortar from joints on steps and monument	
1.4		Localised individual resin repairs to cracked stones on plinth steps, with ss pins to stitch in cracks, allow 4no.

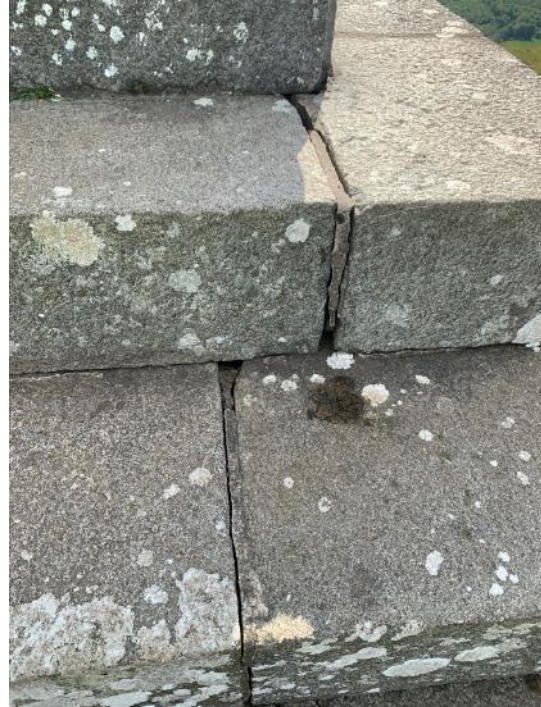
Mortar poor on steps top and face

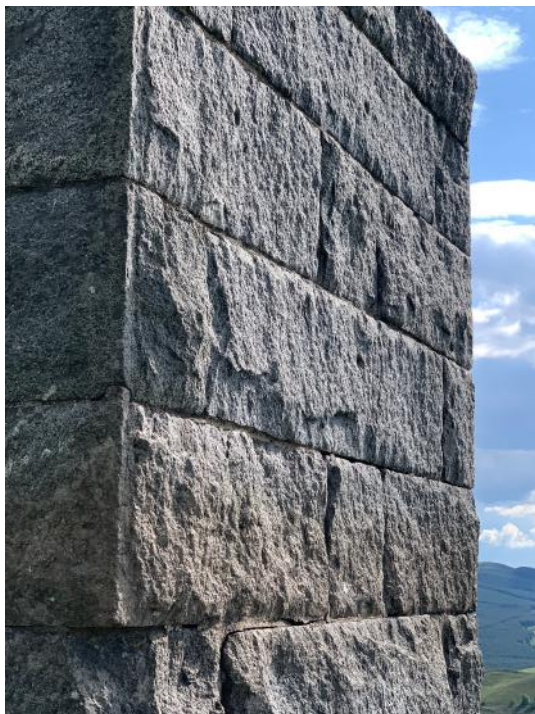
General stone coursing and mortar
In reasonable condition

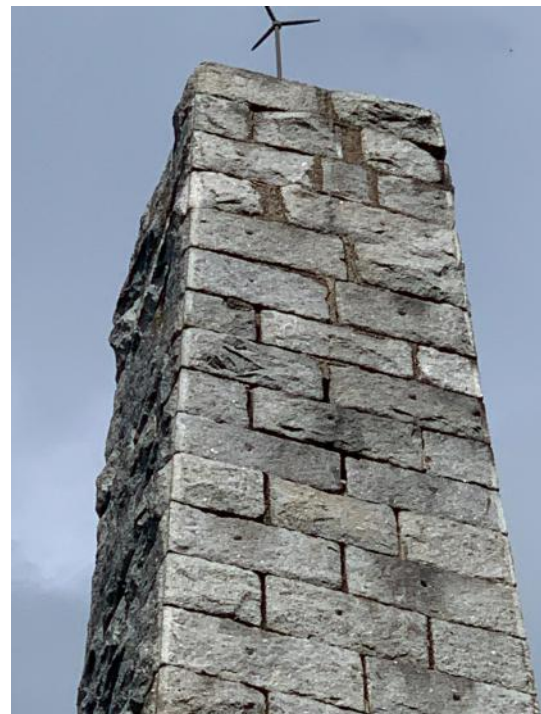
The main shaft of the Obelisk is built with diminishing coursed blocks. There is very little erosion or damage to the blocks, however several corners of blocks have been lost due to long term severe weathering and a few hairline cracks noted, as a common natural defect of granite. Cracks should have resin fill prior to repointing. A fair number of joints have lost mortar, which has been eroded by the weather, particularly noted towards the top and on the South westerly aspect. Complete rake out of mortar and repointing is recommended with wide joints deep packed and all pointed with suitable lime mortar. There are a number of drilled recesses on the face of the obelisk, possibly due to previous scaffold and lightning conductor fixings. The positions could be re-used for fixing to avoid any new holes, and they could be filled with mortar on the removal of the scaffold at completion of the works.

Upper mortar and joints poor and
localised damage of some stones

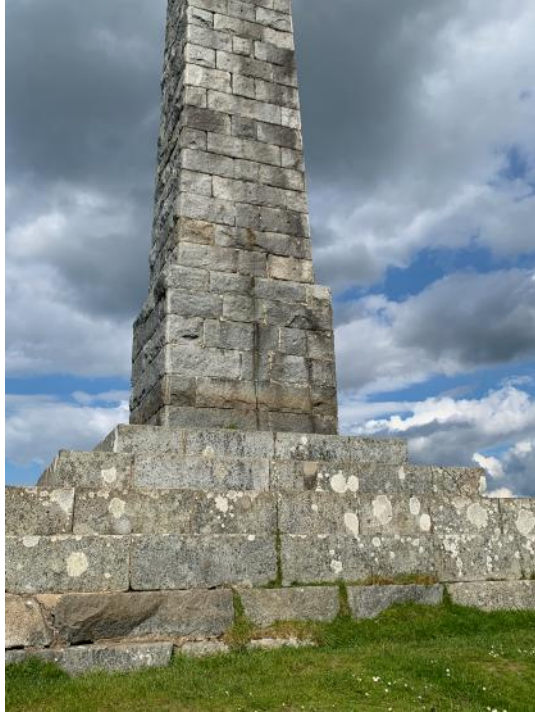
The entire monument is constructed of granite dressed blocks which has very little erosion. There is a small amount of weed and vegetation growth on the plinth steps, rooted in joints of the blocks, and this should be removed.

Plinth steps have some vegetation growing in joints

D	CONSERVATION REPAIR MASONRY WORK		
1.1		Localised removal of vegetation on stepped plinth section on all 4 sides	
1.2		Remove residual lightning conductor tape and fixings, including terminal on cap stone

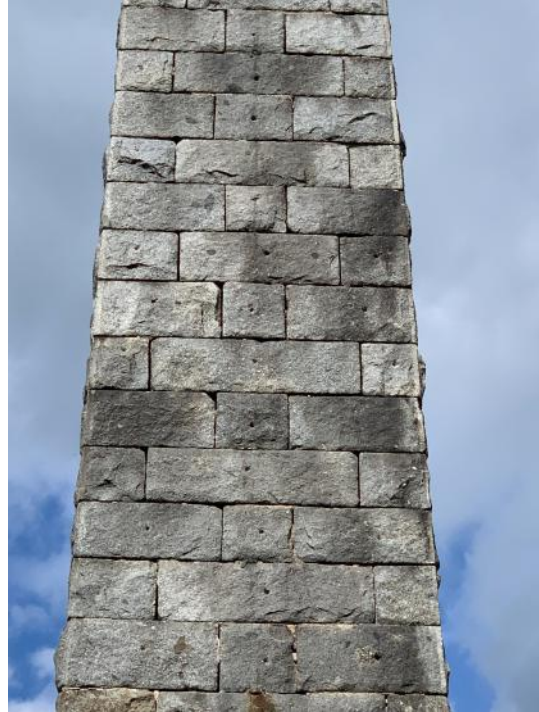
old fixing holes of lost conductor tape and scaffold fixings, to re-use and fill

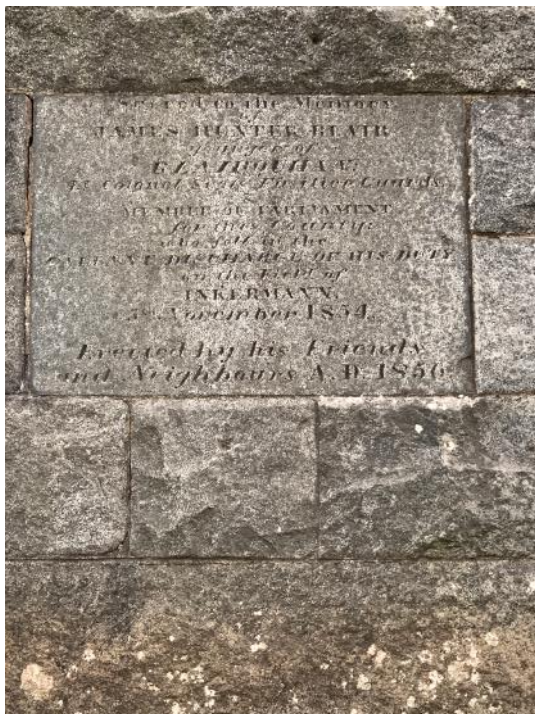
The inscription plaque located on the North east side is still sharp in cut, however the blacking of letters is wearing away with weathering and gentle face cleaning (DOFF steam method) and re-blackening of the lettering is recommended.

Inscription plaque lettering is sharp

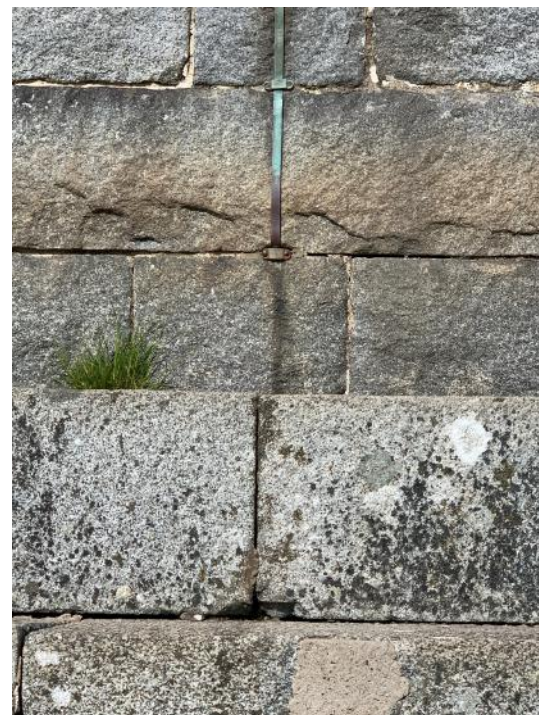
The top of the monument has a lightning conductor rod "tree" and there are some sections of conductor tape to ground level on the South westerly side, however much of this has been lost. A replacement of the lightning conductor installation and ground earthing points should be installed.

old lightning conductor tape remnant

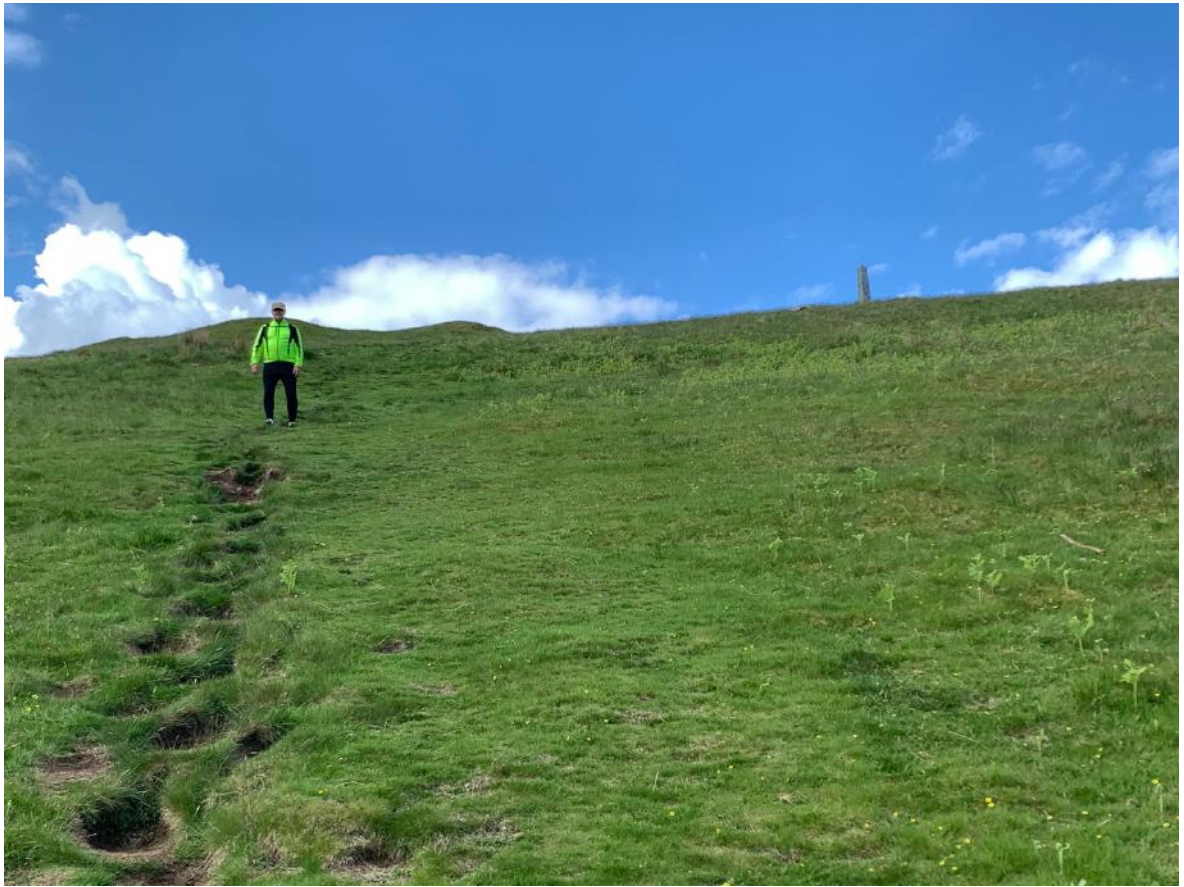
The foot path to the monument is reasonably well worn on the hillside, but is steep and walkers need to be fit to climb the hill. The paths have some wooden signs and a stile over a fence and wall, but these would benefit from improvement. Consideration could be made to providing an information board about the monument at the roadside for general interest of those not able to manage the climb to the monument.

Steep path to monument
