2.5 FOUNDATIONS for RECOVERY

DUNURE HARBOUR CONSERVATION STRATEGY

DUNURE HARBOUR SOUTH AYRSHIRE KA7 4LR

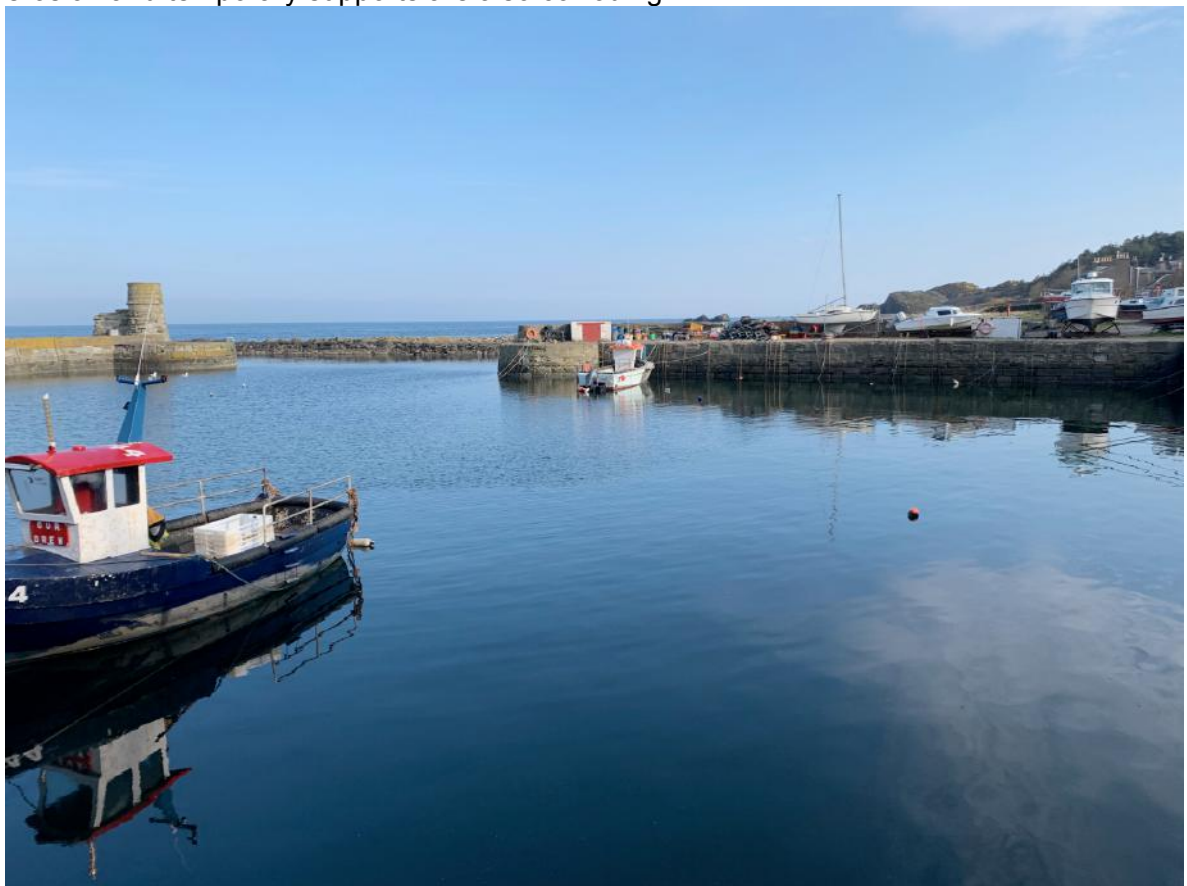
Normal High tide water level rises to the lower coursing of the sandstone on harbour walls

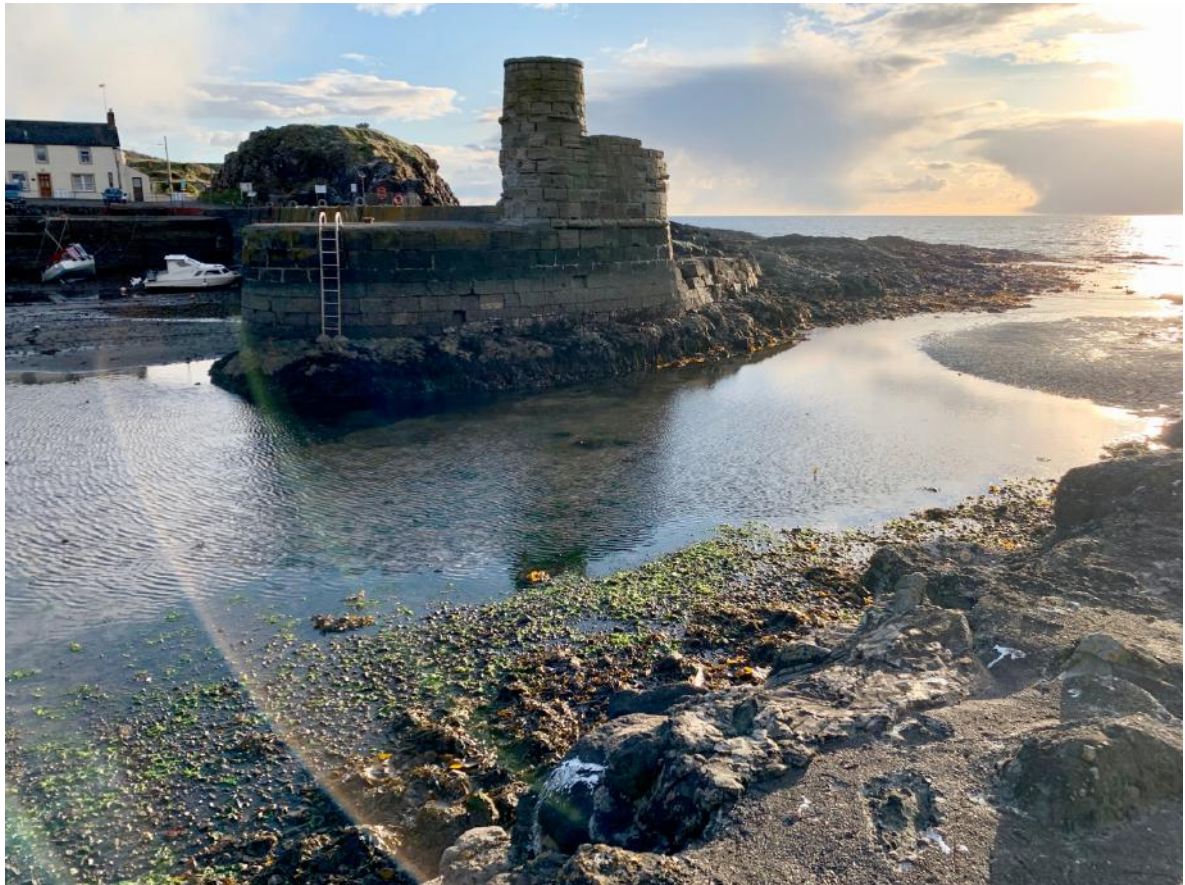
Low tide leaves the harbour basin empty with the entrance channel shallow enough to walk across, exposing the full harbour construction of walls built off rock

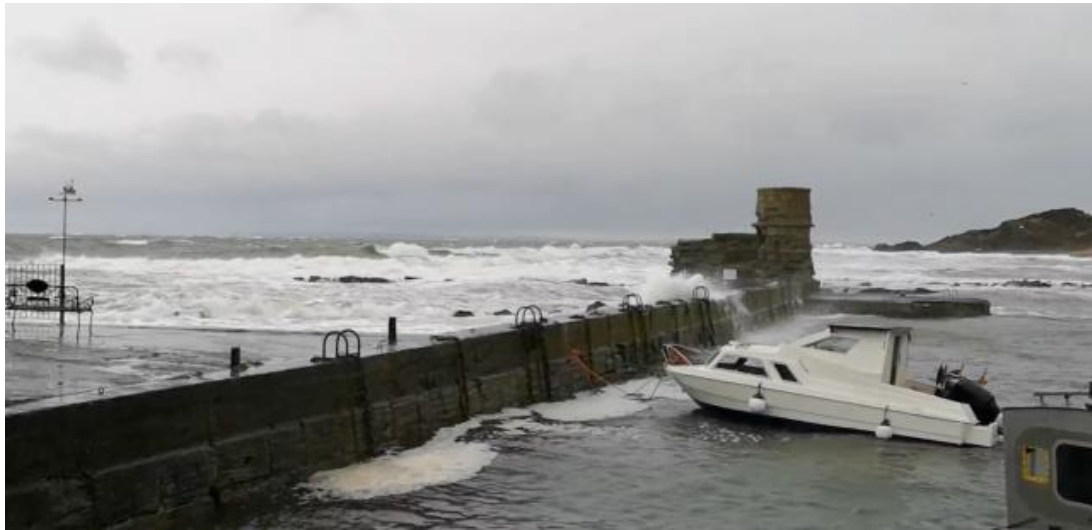
Rough conditions in the harbour during a storm

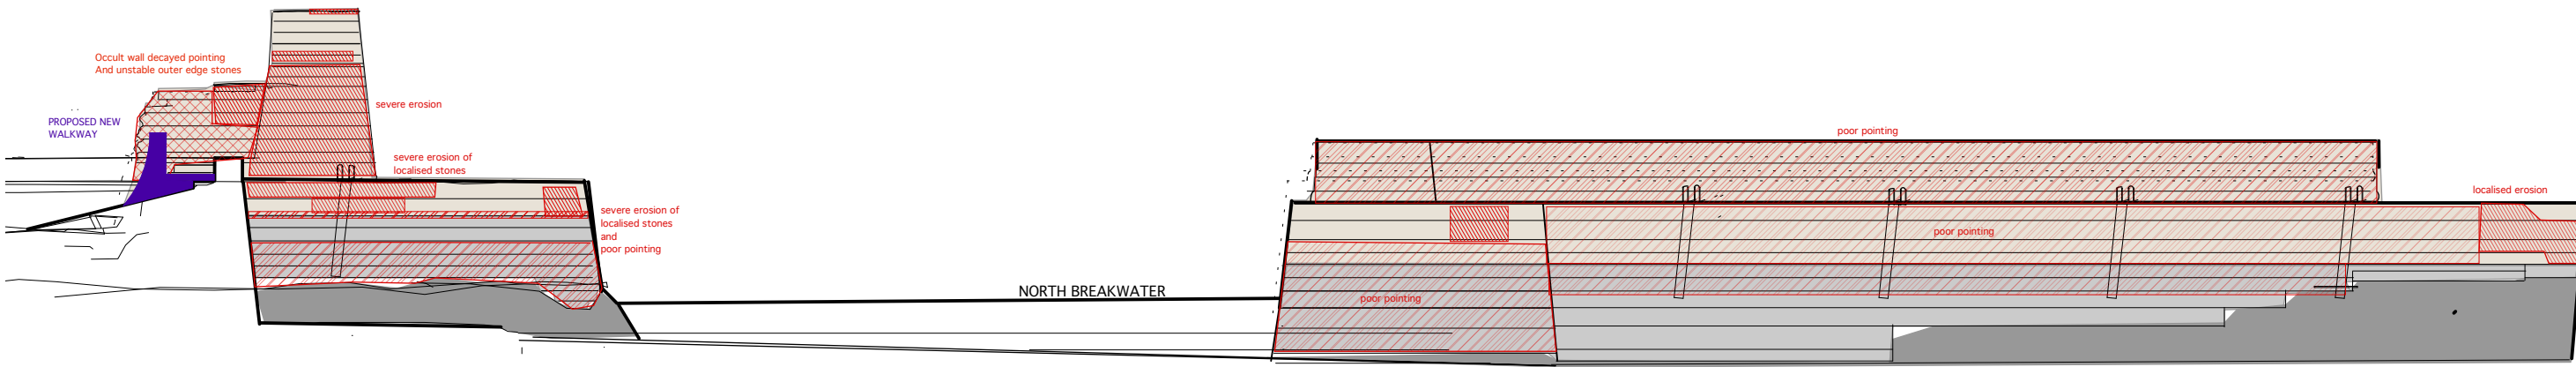
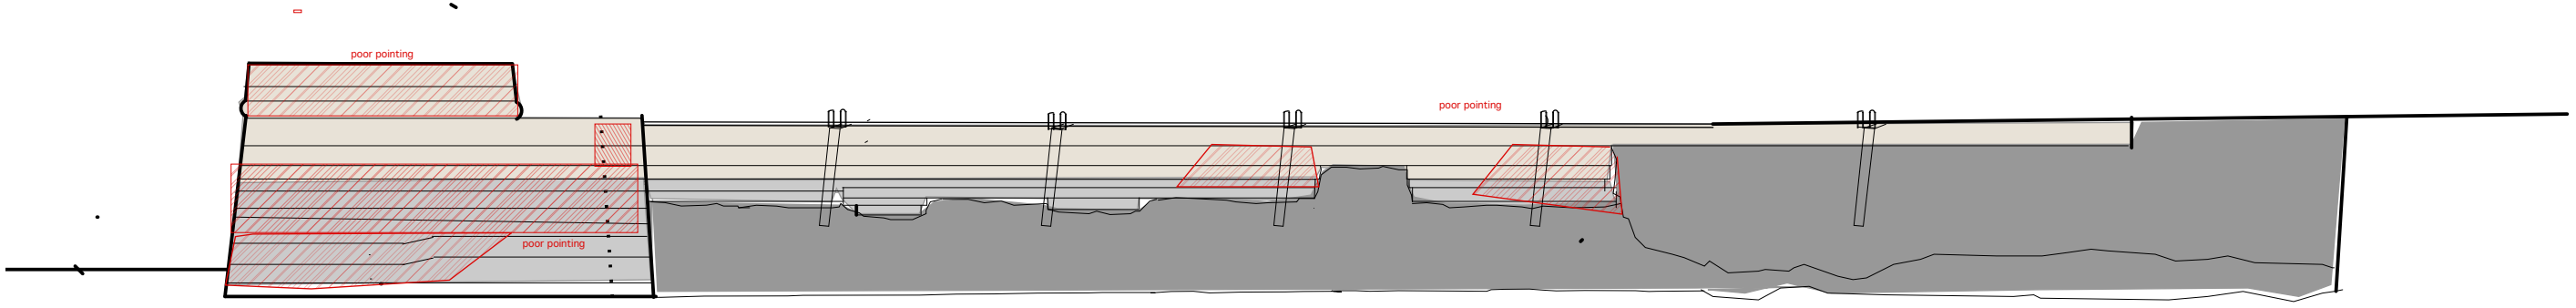
SOUTH FACING ELEVATION HARBOUR WEST WALL LANDING AND NORTH WALL

WEST FACING ELEVATION HARBOUR EAST WALL

JOB			
Dunure Harbour			
DRAWING			
Harbour wall North elevations			
Proposed work			
SCALE	DRAWN	DATE	REV
1:100 @ A1	RC	May 22	
DRAWING NO	REV		
6464/DH/03	PR		
CLIENT			
North Carrick Community Benefit Co.

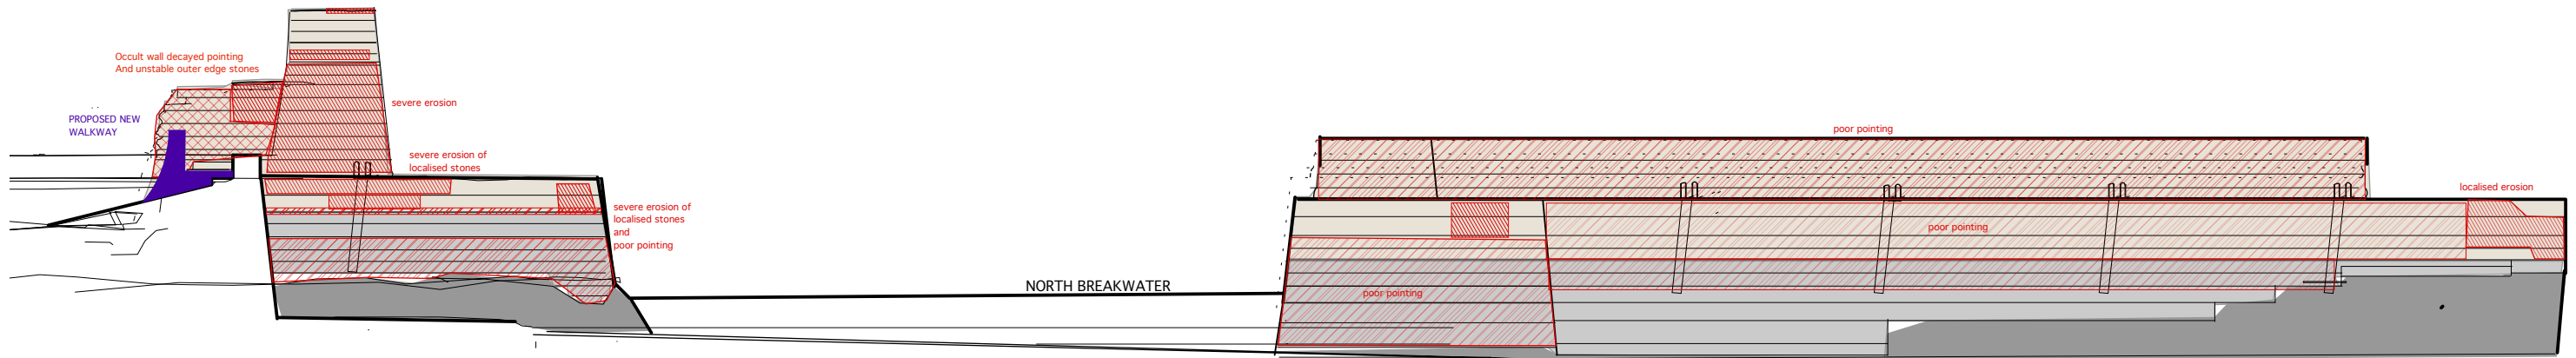
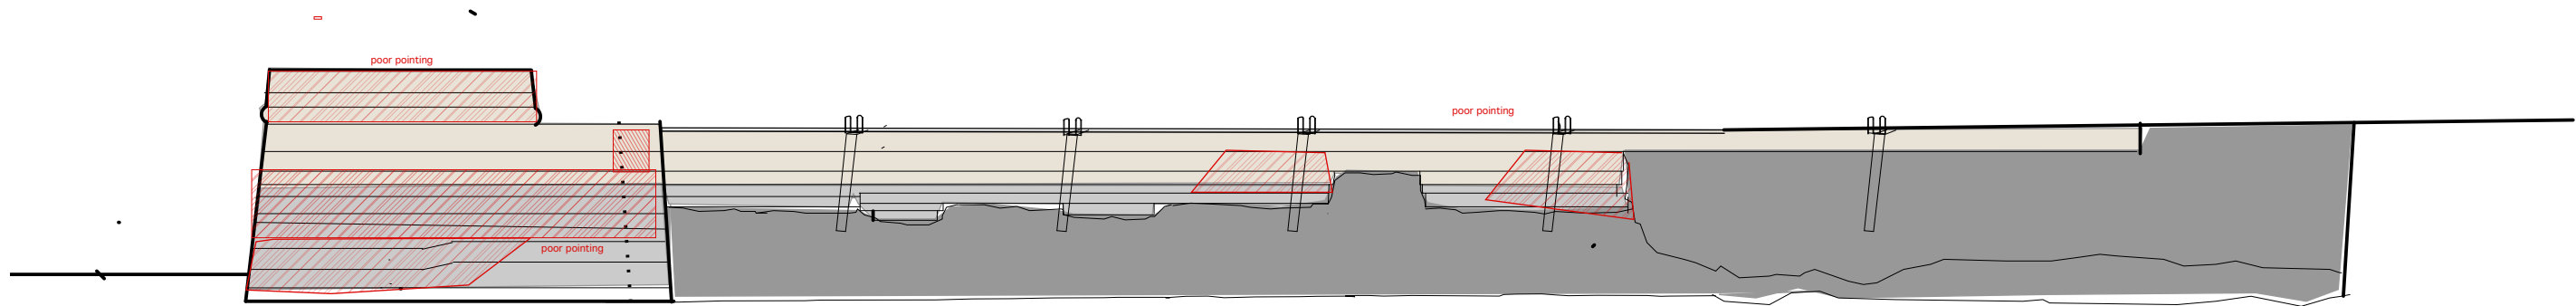
SOUTH FACING ELEVATION HARBOUR WEST WALL LANDING AND NORTH WALL

WEST FACING ELEVATION HARBOUR EAST WALL

JOB Dunure Harbour			
DRAWING Harbour wall South and West elevations Proposed work			
SCALE 1:100 @ A1	DRAWN RC	DATE May 22	REV
DRAWING NO 6464/DH/04 PR	REV		
CLIENT North Carrick Community Benefit Co.
