6.0 FOUNDATIONS for RECOVERY

STRAITON

6.4 McCandlish Hall

6.5 STRAITON MONUMENT CONDITION REVIEW

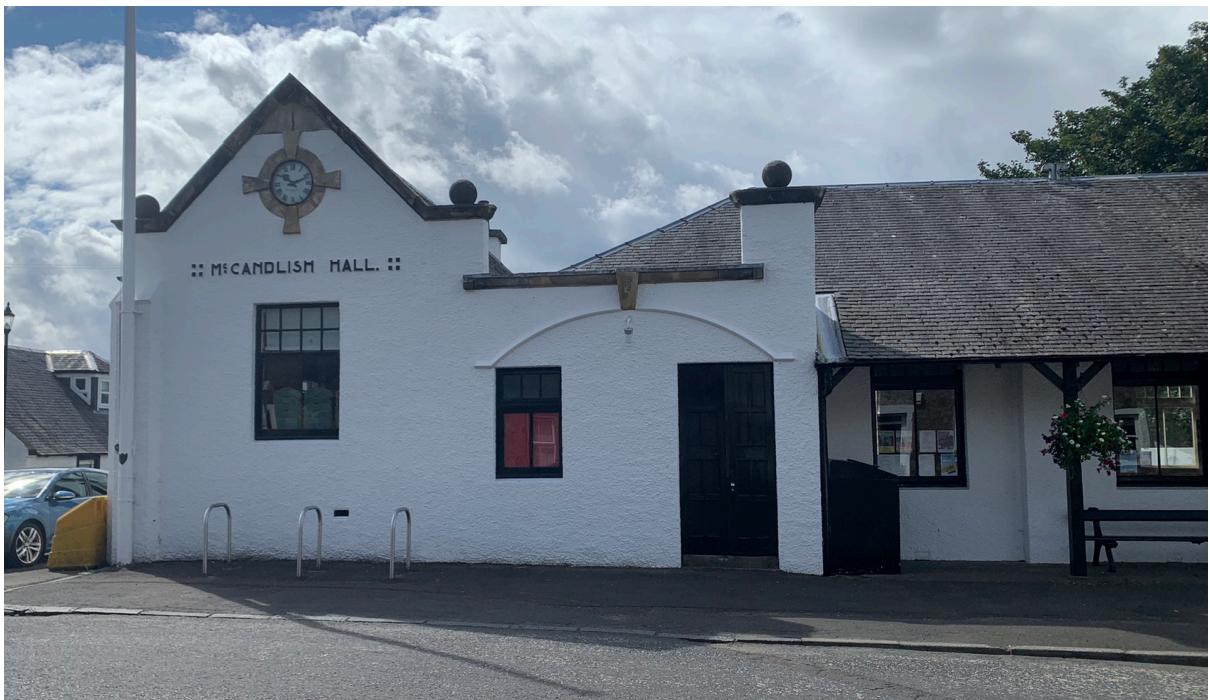
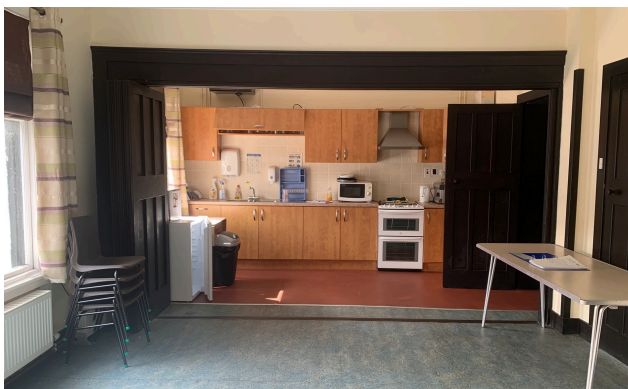
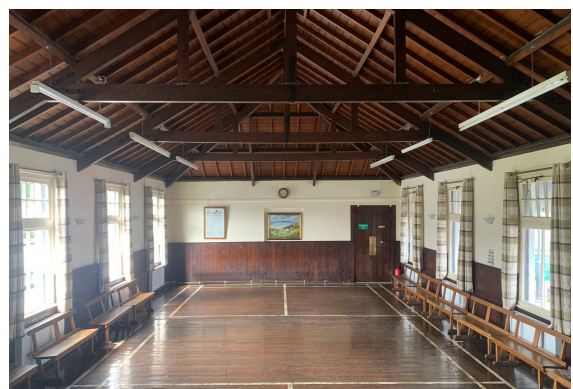
The building has brick walls with roughcast finish, timber floor and roof structures and a slate roof covering. Windows and doors are all timber with the exception of new toilet windows. Overall the building is in reasonably good condition and appears to have been maintained regularly.

- There is one small area of flat roof over the entrance which has been leaking and has caused damage to plasterwork in the hall and first meeting room. We understand action is in hand to address this
- The windows are in relatively poor condition.. They are single glazed timber windows with some signs of wet rot around cills and glazing bars particularly where there is a loss of putty
- The meeting room attic has some areas of missing insulation

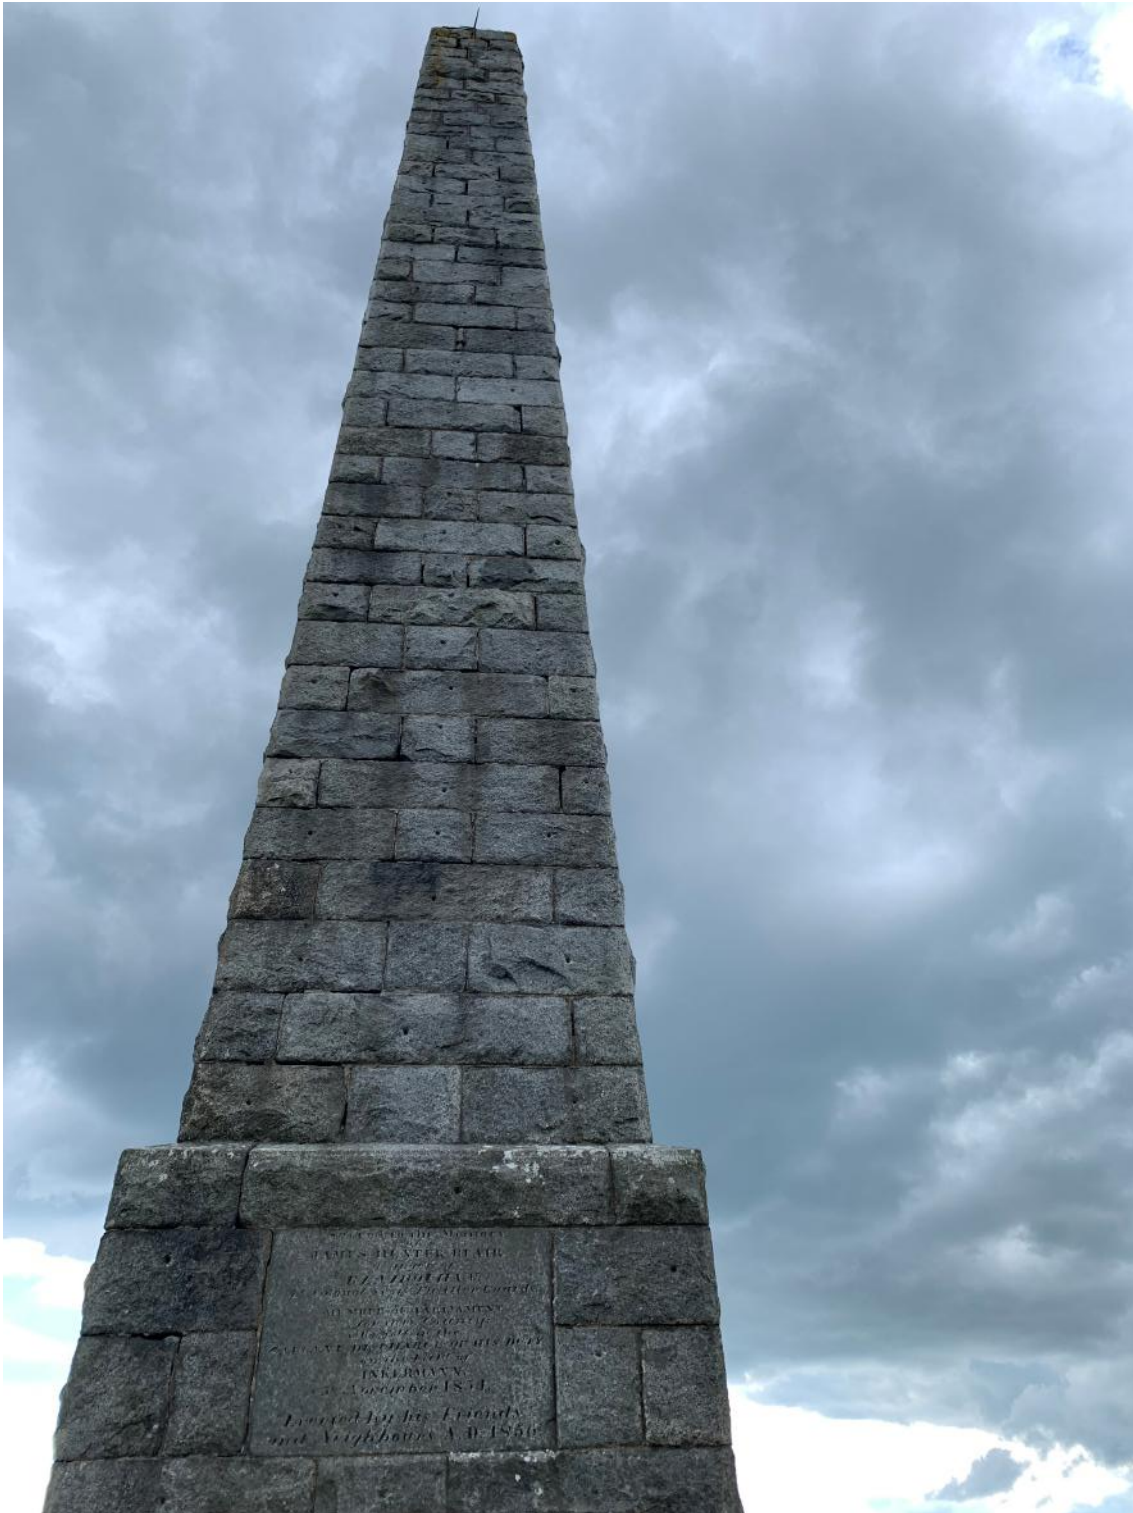
Monument viewed from North east side

The main shaft of the Obelisk is built with diminishing coursed blocks. There is very little erosion or damage to the blocks, however several corners of blocks have been lost due to long term severe weathering and a few hairline cracks noted, as a common natural defect of granite. Cracks should have resin fill prior to repointing. A fair number of joints have lost mortar, which has been eroded by the weather, particularly noted towards the top and on the South westerly aspect. Complete rake out of mortar and repointing is recommended with wide joints deep packed and all pointed with suitable lime mortar. There are a number of drilled recesses on the face of the obelisk, possibly due to previous scaffold and lightning conductor fixings. The positions could be re-used for fixing to avoid any new holes, and they could be filled with mortar on the removal of the scaffold at completion of the works.

The top of the monument has a lightning conductor rod "tree" and there are some sections of conductor tape to ground level on the South westerly side, however much of this has been lost. A replacement of the lightning conductor installation and ground earthing points should be installed.

The inscription plaque located on the North east side is still sharp in cut, however the blacking of letters is wearing away with weathering and gentle face cleaning (DOFF steam method) and re-blackening of the lettering is recommended.

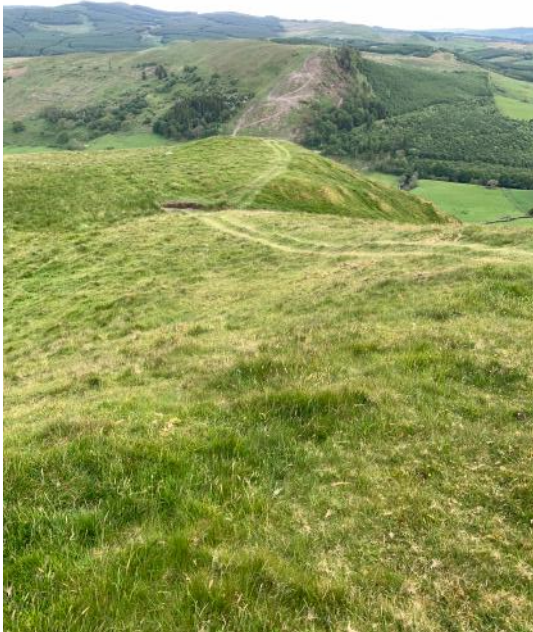
Farm access tracks to top of Craigengower hill

The foot path to the monument is reasonably well worn on the hillside, but is steep and walkers need to be fit to climb the hill. The paths have some wooden signs and a stile over a fence and wall, but these would benefit from improvement. Consideration could be made to providing an information board about the monument at the roadside for general interest of those not able to manage the climb to the monument.
