FOUNDATIONS for RECOVERY

APPENDIX A DUNURE HARBOUR

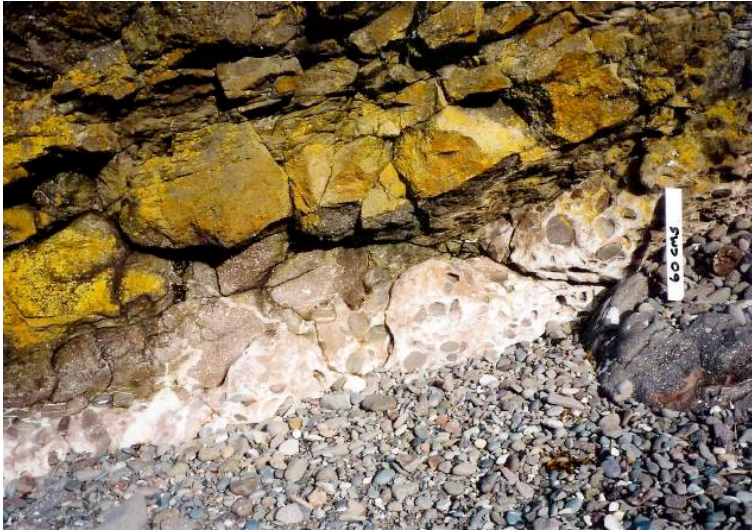
Fig 6: The lava flow is shown dark brown (with yellow lichen) above the paler, whitish-pink conglomerate in which can be seen pebbles and stones of various hues.
